**ST. LOUIS TUNNEL DISCHARGE  
CONSTRUCTED WETLAND PILOT SCALE TEST  
COMPLETION REPORT  
ADDENDUM:**

**SUPPLEMENTAL SAMPLE ANALYSIS RESULTS**

**Rico-Argentine Mine Site – Rico Tunnels  
Operable Unit OU01  
Dolores County, Colorado**

*Prepared by:*  
**AMEC Environment & Infrastructure, Inc.  
Rancho Cordova, California**

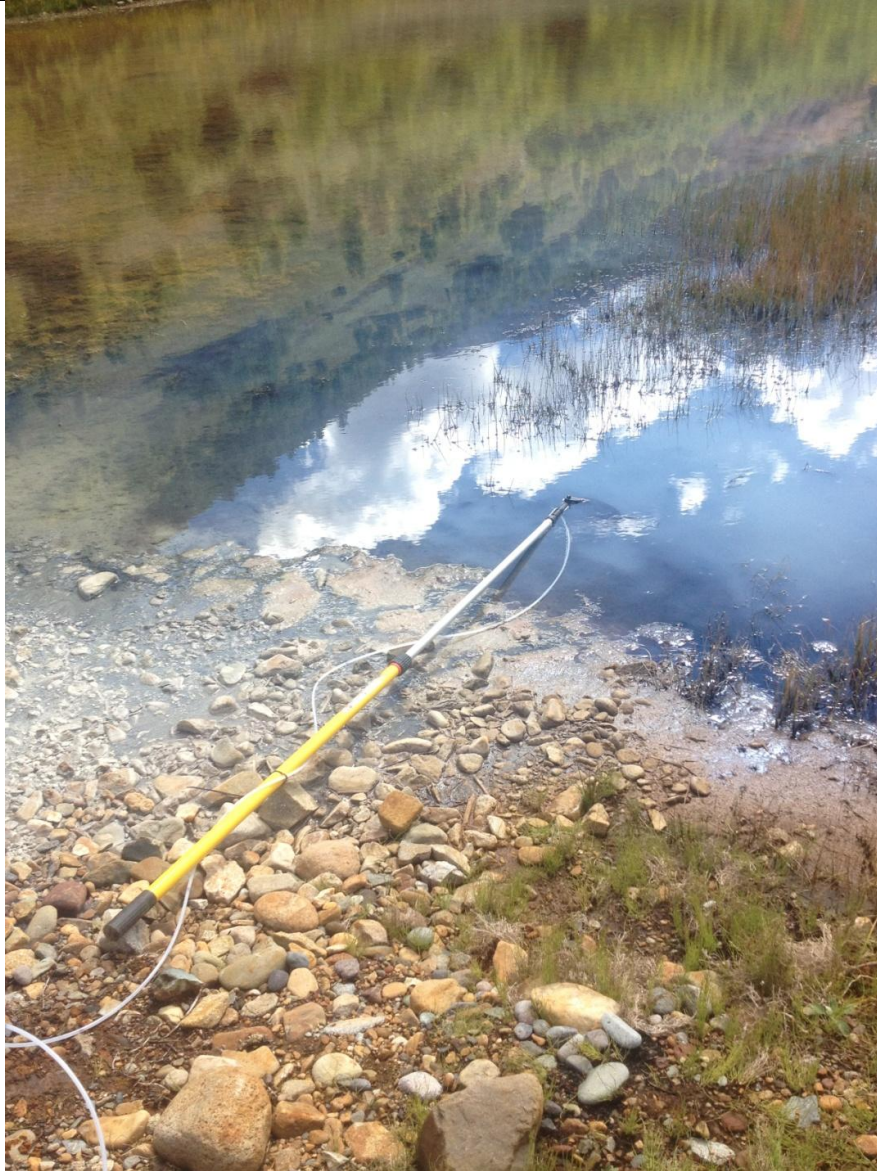
**Photograph 1** Sampling location for Laboratory Sample #1 from Pond 9.

Laboratory Sample #1 (Field Sample POND9FILTRATE13091901) was collected with a peristaltic pump to filter water from the mixing zone in Pond 9 through a flat 0.45-micron ( $\mu\text{m}$ ) filter. The pump intake was located within Pond 9, about five feet west of the pilot-scale wetland discharge point (Photographs 1 and 2 of Attachment A), in an area of the pond where suspended black colloids had been observed visually. This sample was expected to consist of suspended particles, including colloidal metal sulfides.

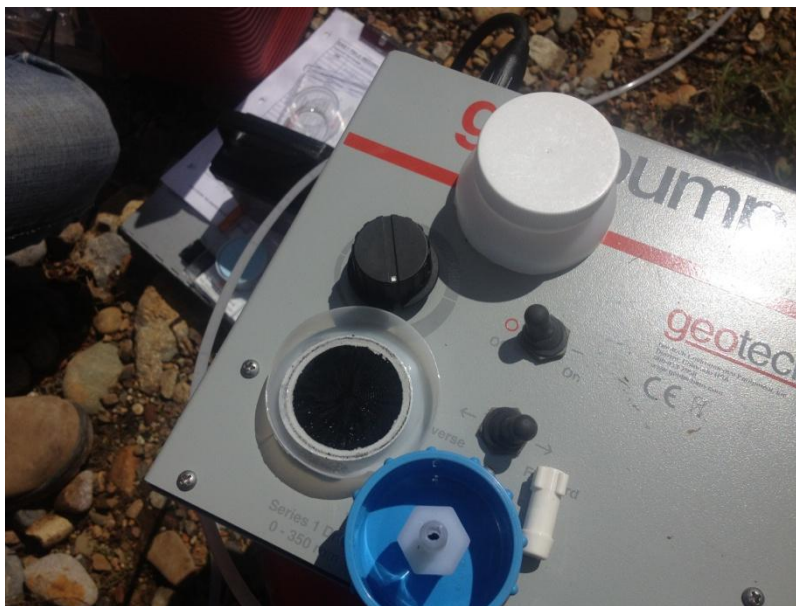
**Photograph 2** Filtration apparatus.

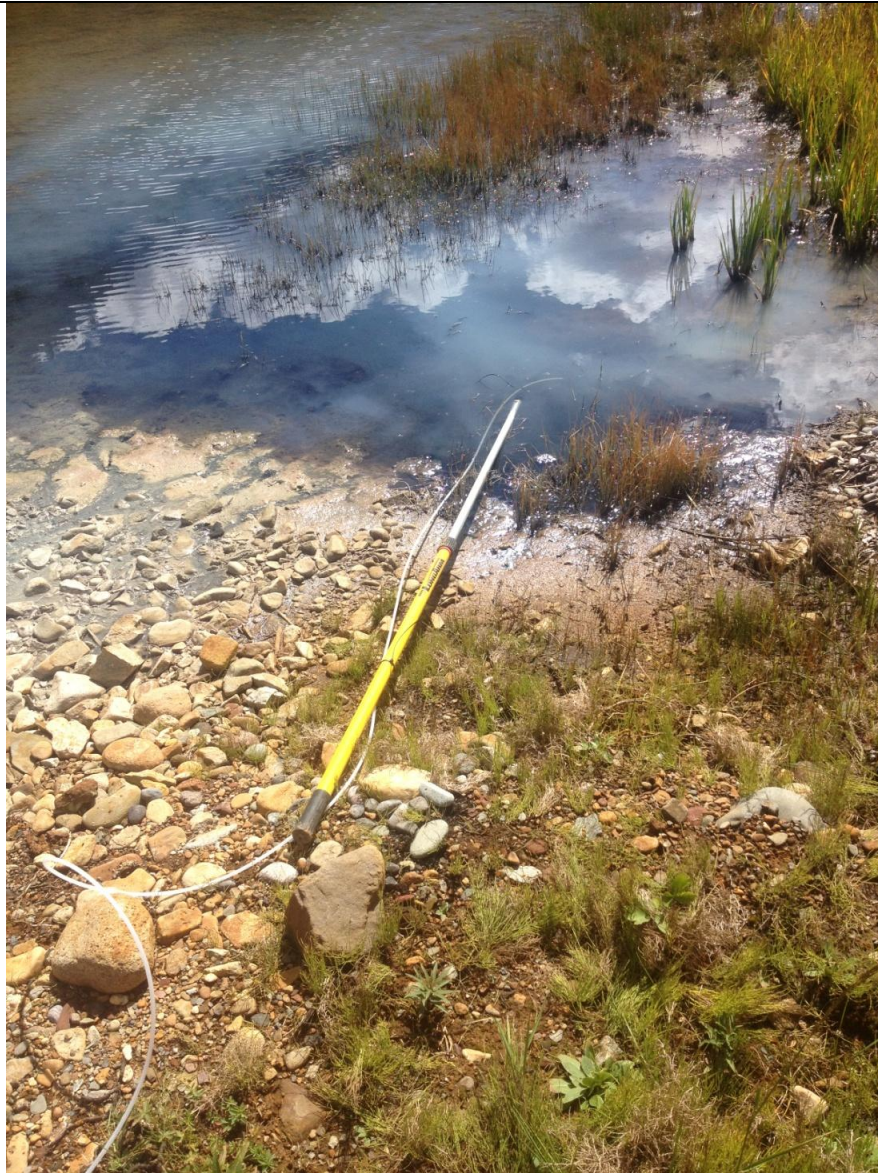
**Photograph 3** Sampling location for Laboratory Sample #2 from Pond 9.

Laboratory Sample #2 (Field Sample POND9FILTRATE13091902) was similarly collected by filtering water from the mixing zone in Pond 9 through a flat 0.45- $\mu\text{m}$  filter. The pump intake was located within Pond 9, about eight feet west of the pilot-scale wetland discharge point (Photographs 3 through 7 of Attachment A), in an area of the pond where suspended grayish colloids had been observed visually. This sample was expected to consist of suspended particles, including colloidal metal sulfides.

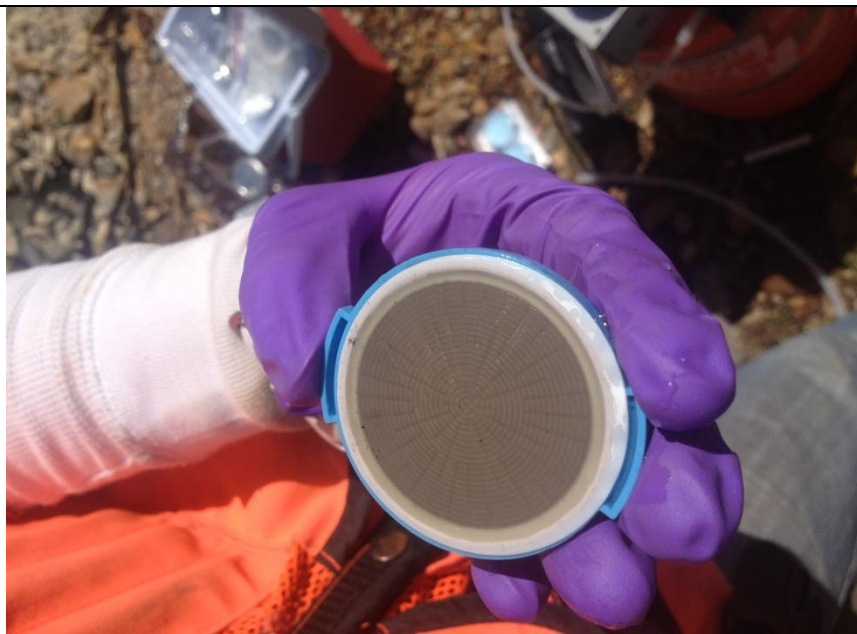
**Photograph 4** Laboratory Sample #2, filter #1 with retained material.

Colloidal materials from the wetland effluent mixing zone in Pond 9, approximately 8 feet west of the wetland discharge location. Sample was collected with a peristaltic pump and 0.45 micron flat filter. Four filters with retained grayish material were submitted for analysis.

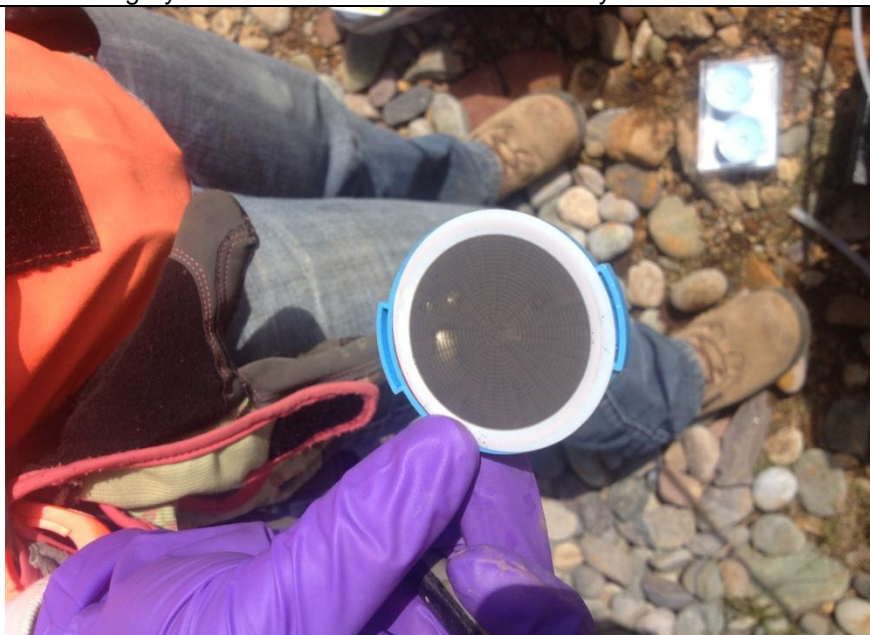
**Photograph 5** Laboratory Sample #2, filter #2 with retained material.

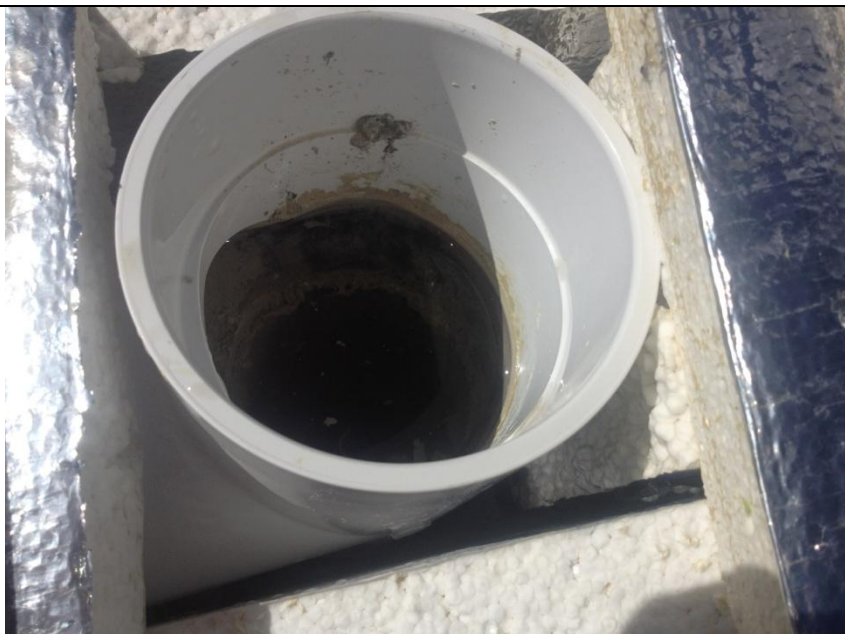
**Photograph 8** Standpipe at subsurface flow wetland effluent.

Laboratory Sample #3 (Field Sample BIOFILMSTANDPIPE130919) consisted of material that had accumulated on the YSI 6920 multi-parameter sonde (sonde) that was deployed in the standpipe at the pilot-scale wetland outlet. The material was scraped off the sonde and onto a coffee filter, which had been suspended over a glass jar to eliminate some of the moisture (Photographs 8 through 10 of Attachment A). After a short drying period, the coffee filter was wrapped around the sampled media and placed inside the glass jar for submittal to the analytical laboratory. This sample was thought to consist of biofilm and/or elemental sulfur.

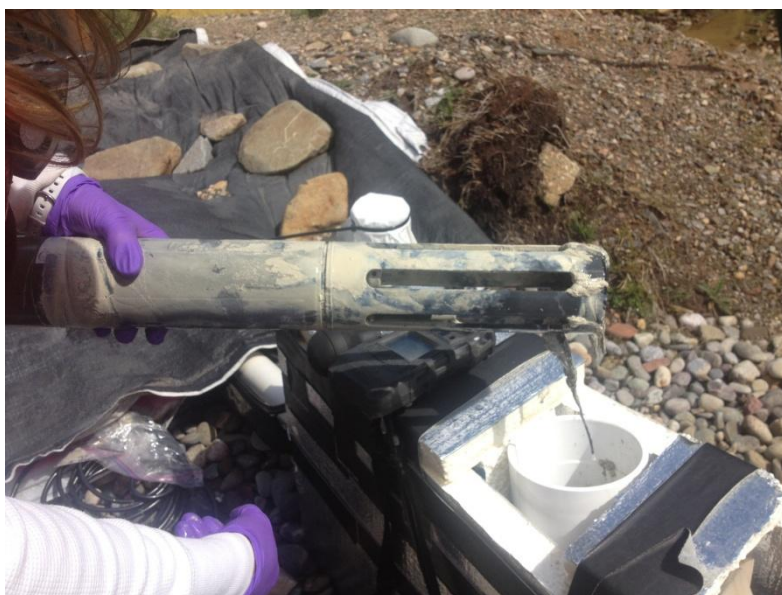
Accumulated material (possibly elemental sulfur and/or biofilm) was sampled from the surface of the sonde deployed in the wetland effluent standpipe.

**Photograph 9** Sample collected from material accumulated on the sonde sensor protective cover

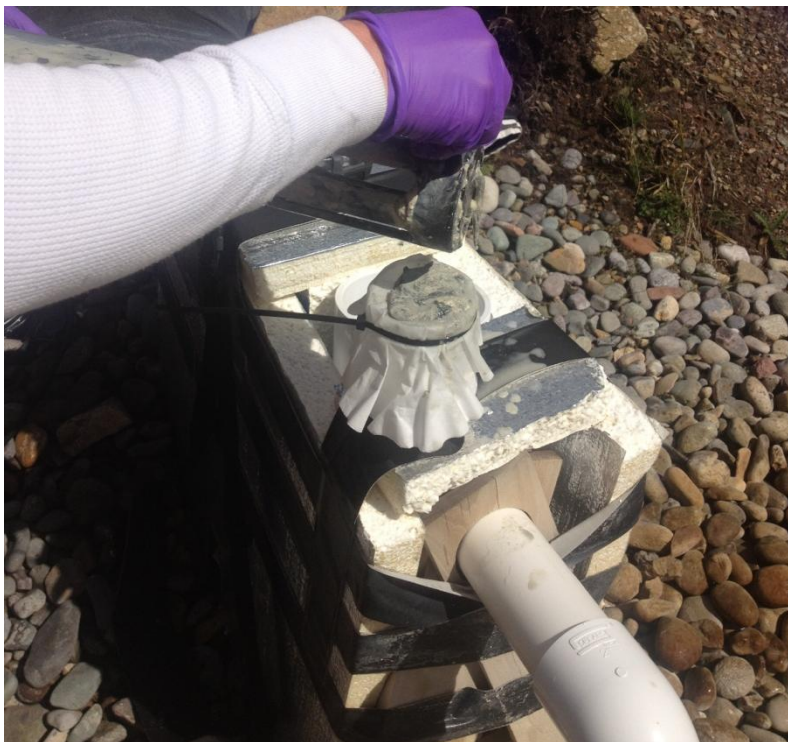
**Photograph 10** Sample placed onto a mason jar fitted with a coffee filter to reduce moisture content of the sample.

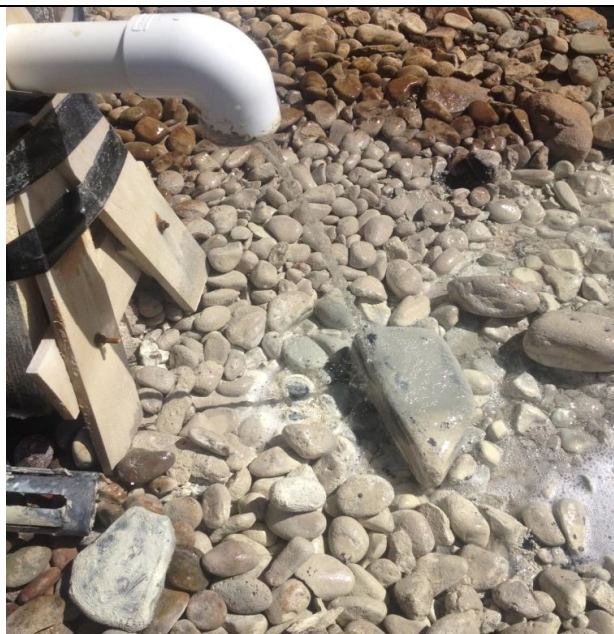
**Photograph 11** Grayish material (possibly elemental sulfur and/or biofilm) covering the rocks below wetland effluent discharge point.

**Laboratory Sample #4**

Field Sample ID: **BIOFILMROCK130919**

Accumulated material (possibly elemental sulfur and/or biofilm) was sampled from the surface of the rocks below the wetland effluent discharge point.

Laboratory Sample #4 (Field Sample BIOFILMROCK130919) consisted of material that had accumulated on the surface of the rocks immediately downgradient of the pilot-scale wetland discharge point. The material was scraped off several rocks and onto a coffee filter, which had been suspended over a glass jar to eliminate some of the moisture (Photographs 11 through 13 of Attachment A). After a short drying period, the coffee filter was wrapped around the sampled media and placed inside the glass jar for submittal to the analytical laboratory. This sample was thought to consist primarily of elemental sulfur.

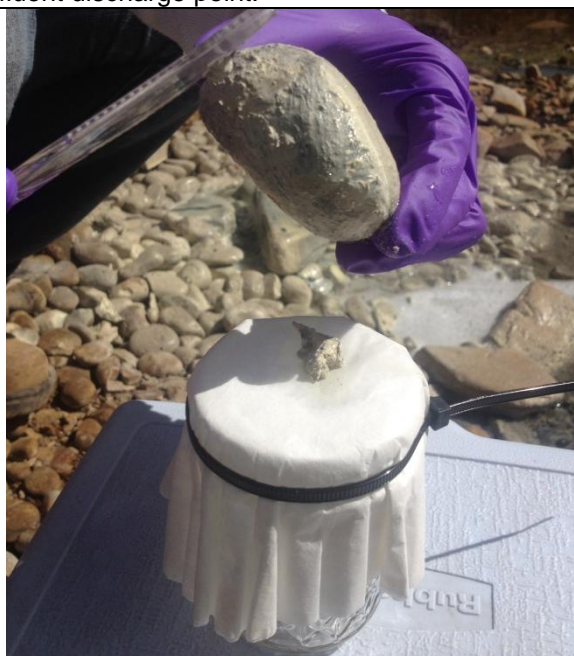
**Photograph 12** Removing coating from rocks.

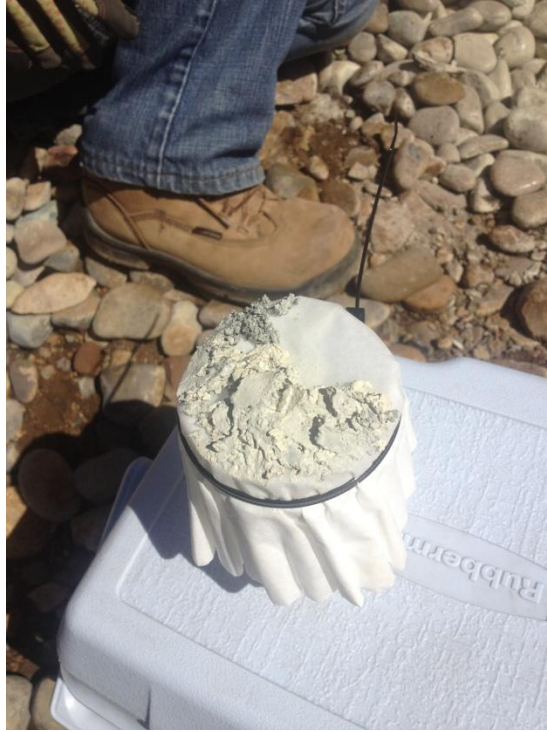
**Photograph 13** Sample material removed from rocks and placed on coffee filter to reduce moisture content.

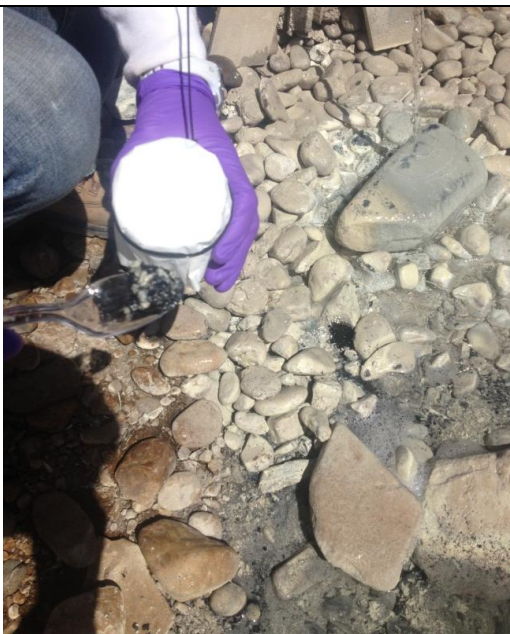
**Photograph 14** Collecting sediment sample, after displacing upper rocks.

**Laboratory Sample #5**

Field Sample ID: **BLACKSEDIMENT130919**

Black sediment (presumed to be metal sulfides) was sampled from beneath the surface rocks that were coated with sulfur and/or biofilm (Laboratory Sample #4). Material was beneath wetland effluent discharge point.

Laboratory Sample #5 (Field Sample BLACKSEDIMENT130919) consisted of black material that had accumulated on subsurface rocks beneath the sulfur/biofilm covered rocks immediately downgradient of the pilot-scale wetland discharge point. The material was scraped off several rocks and onto a coffee filter, which had been suspended over a glass jar to eliminate some of the moisture (Photographs 14 and 15 of Attachment A). After a short drying period, the coffee filter was wrapped around the sampled media and placed inside the glass jar for submittal to the analytical laboratory. This sample was thought to consist primarily of metal sulfides due to the black appearance of the sample.

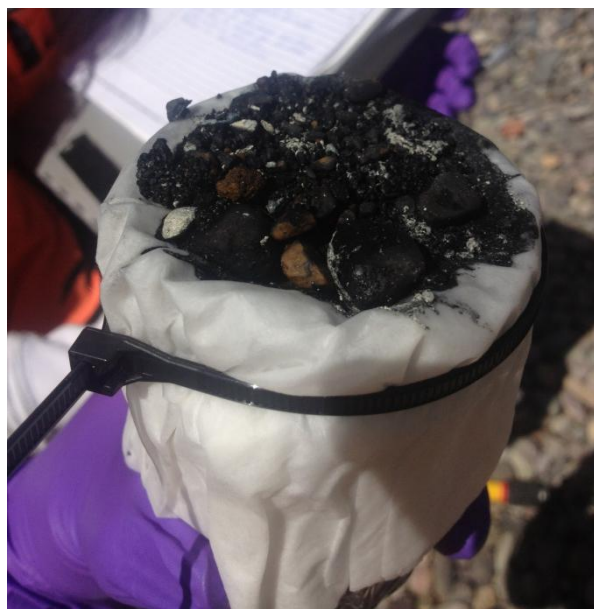
**Photograph 15** Black sediment material, placed on coffee filter to reduce moisture content.

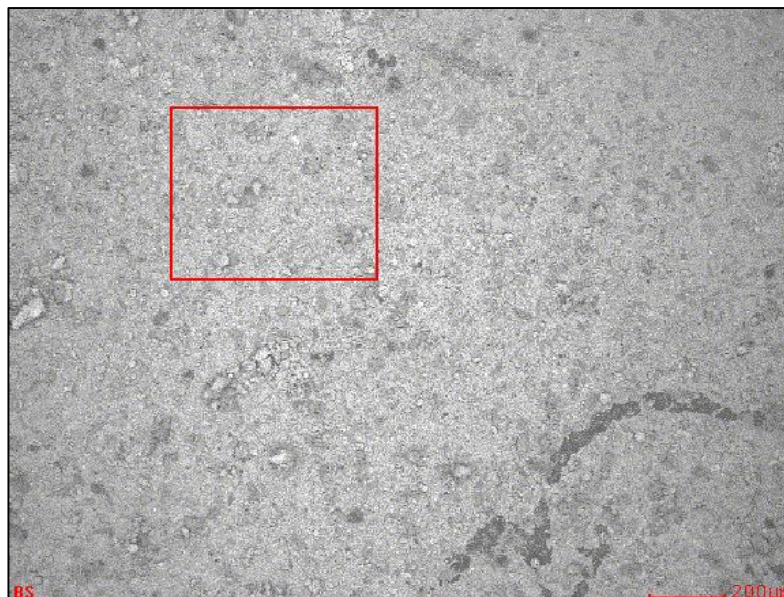
Element	Wt%	At%
CK	18.39	32.14
OK	31.17	40.91
MgK	00.59	00.51
AlK	02.92	02.27
SiK	09.07	06.78
PK	00.19	00.13
SK	11.44	07.49
KK	00.87	00.47
CaK	01.29	00.67
MnK	01.61	00.61
FeK	14.70	05.53
ZnK	07.77	02.50
Matrix	Correction	ZAF

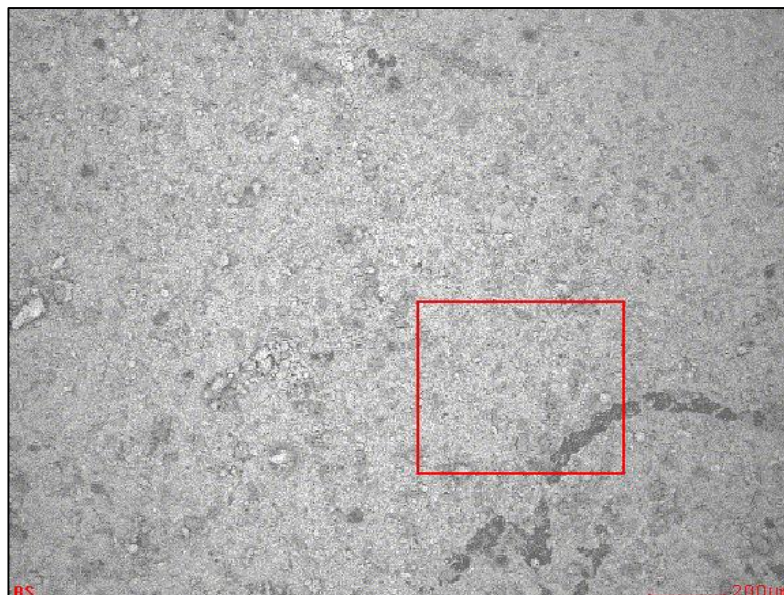
Element	Wt%	At%
CK	19.10	33.41
OK	30.38	39.90
MgK	00.48	00.41
AlK	02.76	02.15
SiK	09.09	06.80
PK	00.27	00.18
SK	11.00	07.20
KK	00.89	00.48
CaK	00.85	00.44
MnK	01.54	00.59
FeK	15.25	05.74
ZnK	08.41	02.70
Matrix	Correction	ZAF

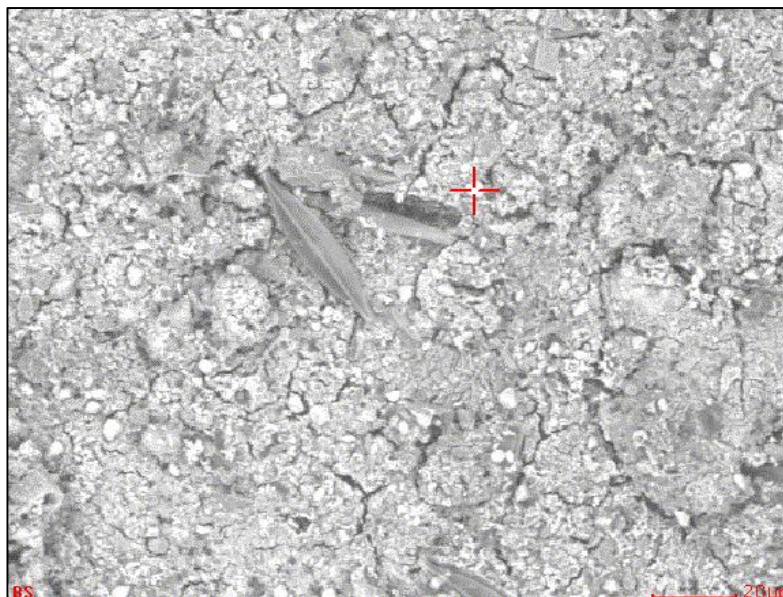
Element	Wt%	At%
CK	08.72	18.85
OK	11.45	18.58
MgK	00.27	00.28
AlK	00.57	00.55
SiK	01.63	01.51
PK	00.23	00.19
SK	70.19	56.83
KK	00.24	00.16
CaK	00.36	00.23
MnK	00.40	00.19
FeK	03.81	01.77
ZnK	02.14	00.85
Matrix	Correction	ZAF

- Sample1\_10 – The particle in this location had high S concentration (70% by weight), indicating that the focus is on an elemental sulfur granule. Other particles of similar size, shape, and brightness are observed in the field of view, strongly suggesting the presence of other S granules in this view. Based on the 20- $\mu\text{m}$  scale, the diameter of many of these granules is about 2-5  $\mu\text{m}$ , and are clay or small silt-sized particles. Darker material in this view may consist of fine Fe- and Zn-rich particles (likely sulfides), which may have been discharged from the wetland as colloidal metal sulfides or may have been formed in the pond by reaction of discharged sulfides with metals in pond water.

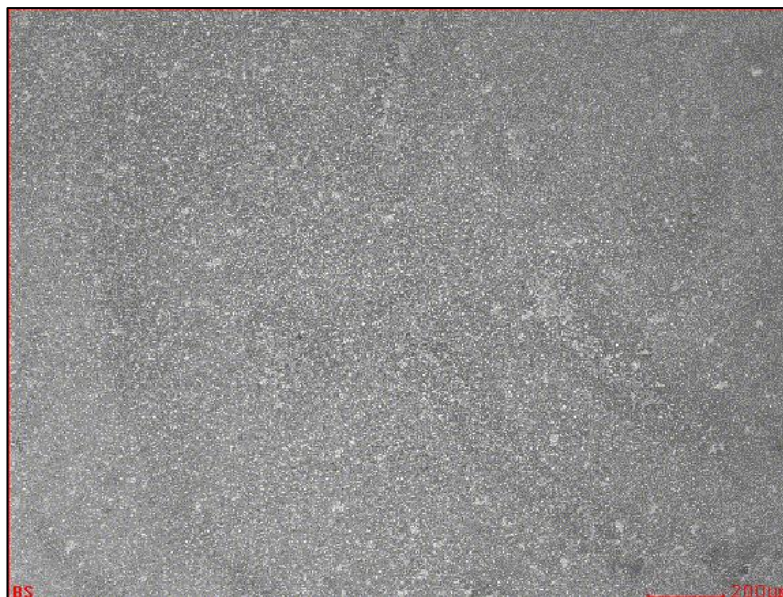
Element	Wt%	At%
CK	49.10	63.05
OK	28.66	27.63
AlK	00.22	00.12
SiK	00.52	00.29
PK	00.26	00.13
SK	14.48	06.97
CaK	00.29	00.11
FeK	04.36	01.20
ZnK	02.12	00.50
Matrix	Correction	ZAF

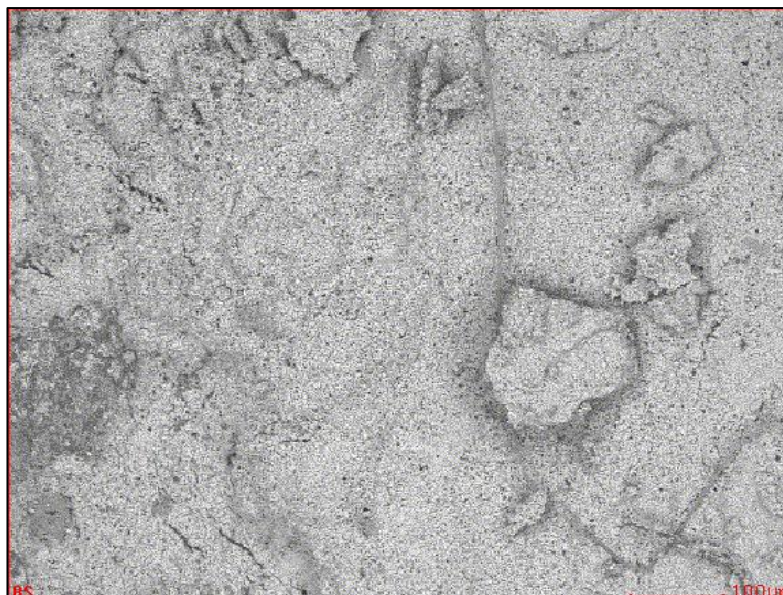
Element	Wt%	At%
CK	22.66	40.69
OK	11.01	14.84
SK	65.38	43.97
CaK	00.94	00.50
Matrix	Correction	ZAF

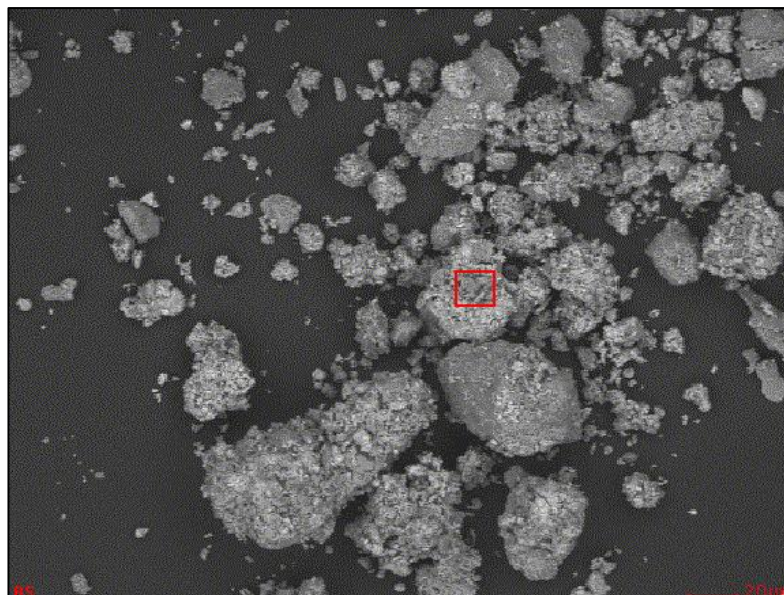
Element	Wt%	At%
CK	29.08	47.97
OK	21.16	26.21
NaK	01.41	01.21
MgK	00.35	00.29
AlK	02.08	01.53
SiK	07.41	05.23
PK	00.16	00.10
SK	14.31	08.84
KK	00.90	00.45
CaK	01.60	00.79
MnK	00.72	00.26
FeK	15.54	05.51
ZnK	05.27	01.60
Matrix	Correction	ZAF
